DEPUTY MINISTRY OF TOURISM

HOTEL ESTABLISHMENTS WITH FACILITIES FOR PEOPLE WITH ACCESS NEEDS			
Name of the establishment:		VASSOS NISSI PLAGE	
Category:		HOTEL	
Website:		www.vassosnissiplage.com.cy	
Address:		82 Nissi Ave., Agia Napa	
Date of inspection:		12/4/2017	
Facilities			
1 Parking Facilities for persons with disabilities

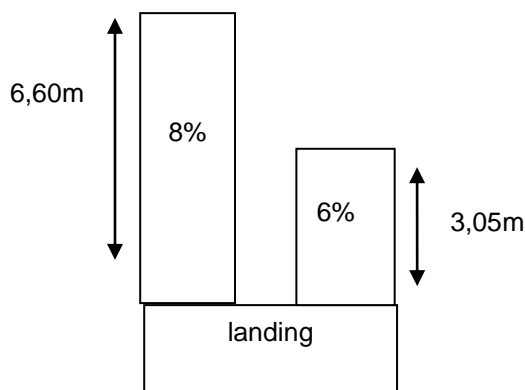
- (At the entrance there is a ramp with double supporting handrails) - length and slope as shown in the diagram below: There is a ramp at the entrance with double supporting handrails

- The ramp floor is marble with metallic rails.
